Drift-Based Functional Fragility Framework for Fire-Rated Doors in Post-Earthquake Fires

Abstract. This study evaluates the expected post-earthquake fire performance of fire-rated door assemblies by integrating structural drift demands from full-scale seismic testing with fire door fragility characterization. A fragility curve for 90-minute-rated fire doors is first developed based on the experiments of Calayir et al. [2022], in which doors were subjected to quasi-static cyclic loading followed by standard fire resistance tests. The resulting curve relates inter-story drift ratio (IDR) to the probability of fire rating loss, indicating reductions of approximately 70% at drift levels around 2%. The fragility curve is then applied to the partition walls in a steel-moment-resisting frame specimen reported by Huang et al. [2022], where a full-scale, four-story steel moment-resisting frame was subjected to increasing ground motions. Recorded IDRs reached approximately 1.45% at the second story. By mapping these drift demands to the fragility curve, the likely degradation in fire performance of hypothetical fire door sets is inferred for each story. This approach constitutes the first q

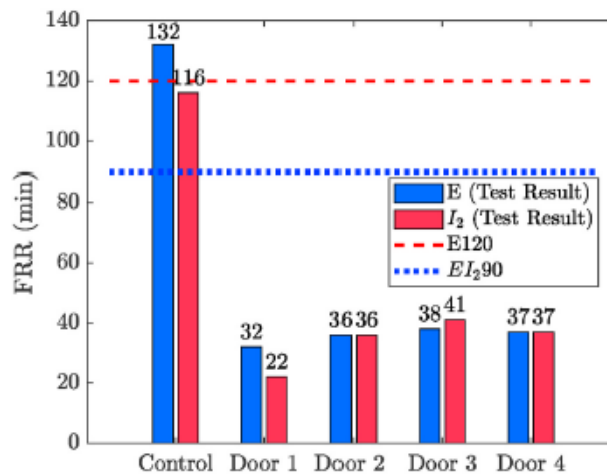
Figure 3. Residual fire resistance of 90-min rated fire doors versus inter-story drift ratio, based on data from Calayir et al. [2022]. Higher seismic drifts lead to drastic reductions in fire endurance (approximately 70% loss at 2.3 % IDR)

The fire exposure tests revealed drastic reductions in fire endurance for the earthquake-damaged doors. All three door sets that underwent seismic loading failed to achieve even half of the original 90-minute rating. Table 1 and Figure 3 summarize the outcomes. While an undamaged control door easily survived the full 90-min (and indeed had no integrity or insulation failure even at 2 hours, demonstrating some safety margin), the drifted specimens failed between about 30 and 40 minutes under the same fire test. The mode of fire failure for the damaged doors was integrity failure: due to the quake-induced gaps, hot gases and flames penetrated the door-frame interface well before 90 minutes. In Calayir et al. [2022] tests, flaming was observed around the warped frame edges after roughly 30–40 minutes of fire exposure, leading to the cotton pad ignition criterion being met (i.e. fire breaching). Additionally, thermocouples on the frame registered rapid temperature rise – one door exceeded the 360 °C frame temperature limit at around 40 min. All damaged doors thus failed the integrity criterion by 40 min, versus the control door which maintained integrity past 120 min. The insulation criterion (average door temperature rise) was satisfied for the damaged doors up to their failure time, meaning the door panels themselves did not overheat; it was the through-gap hot gas leakage that caused failure. This highlights that gaps and distortions, not panel burn-through, were the critical weakness in the post-quake fire performance. With only three data points, Calayir et al. [2022] did not demonstrate fitting a specific probability distribution; however, the implication is that the fragility function for fire door failure (loss of rating) is steep – likely a lognormal curve. The authors succinctly stated: “The fire performance of 90-min rated door sets reduced approximately 70% in terms of insulation and integrity failure.” They recommend that post-earthquake inspections measure door frame gaps, and if gaps exceed ~8 mm (which corresponded to ~2% IDR in their tests), the door should be considered compromised.

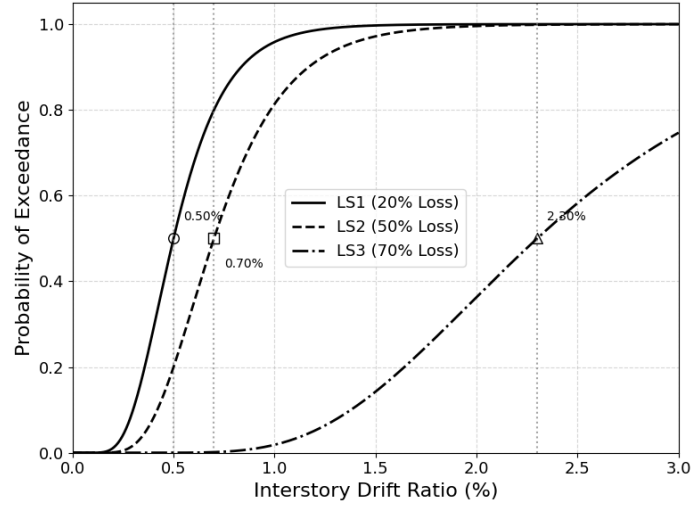
Figure 4. Drift-based fragility curves for fire-rated door assemblies showing probability of exceedance for three functional loss states (LS1–LS3) as a function of interstory drift ratio.

$$P(LS \geq i \mid IDR) = \Phi((\ln(IDR) - \ln(m_i))/\beta)) \quad (2)$$

where m_i is the median drift, $\beta = 0.4$ is the logarithmic standard deviation [Miranda et al. 2003] for interior doors), and Φ is the standard normal cumulative distribution.

The three fragility curves describe the probability of exceeding each loss state as a function of drift (Figure 4). To relate these exceedance probabilities to residual fire performance, an expected functionality curve was derived as seen in Figure 5, expressing the mean retained FRR at each drift level:

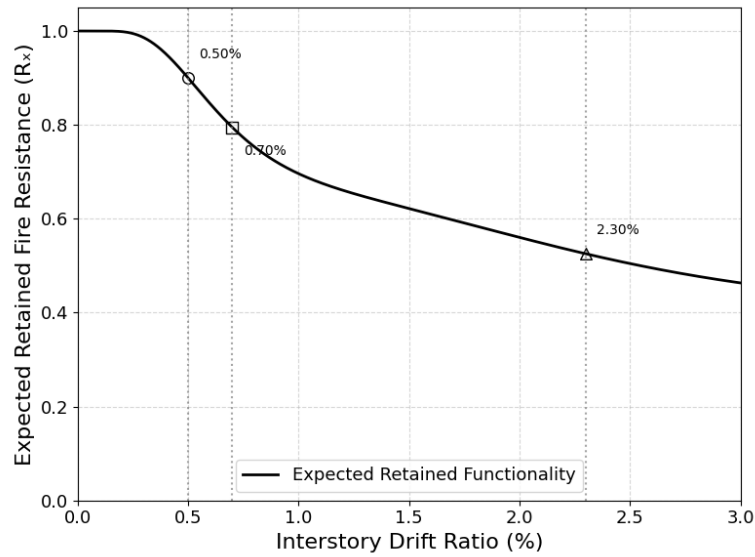
Figure 5. Functional loss curve of the fire-rated door showing retained FRR with increasing drift

This curve transitions from $E[R_f] = 1.0$ and $E[R_f] = 0.3$ at 2.0–2.5 % IDR reflecting the progressive degradation of fire-door performance with increasing seismic deformation.
